**AIRCRAFT
ACCIDENT
REPORT**
Trans World Airlines Flight 800
Part I
Consideration of Reasonable Probable Causes

**Report on the accident to
Trans World Airlines Flight 800
Boeing 747-131, N93119
Near East Moriches, New York
July 17, 1996
by John Barry Smith,
Independent Aircraft Accident Investigator**

Part I: Consideration of Reasonable Probable Causes

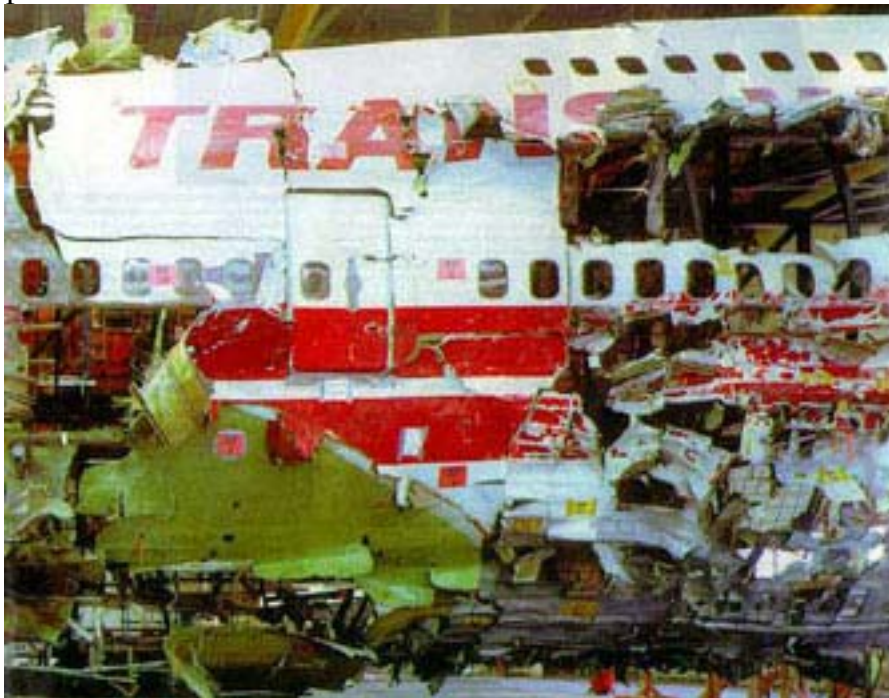
Above/previous page is a NTSB photograph of the wreckage reconstruction of Trans World Airlines Flight 800 starboard side over and forward of the wing. Fuselage station 600 is to the right extending to fuselage station 960 to the left in the photograph. A little over half of the forward cargo door is the shattered area in the lower right hand section. An outward opening petal shaped rupture can be seen at the aft midspan latch of the forward cargo door. The mildly damaged right hand, number two passenger door is in the middle left of the photograph.

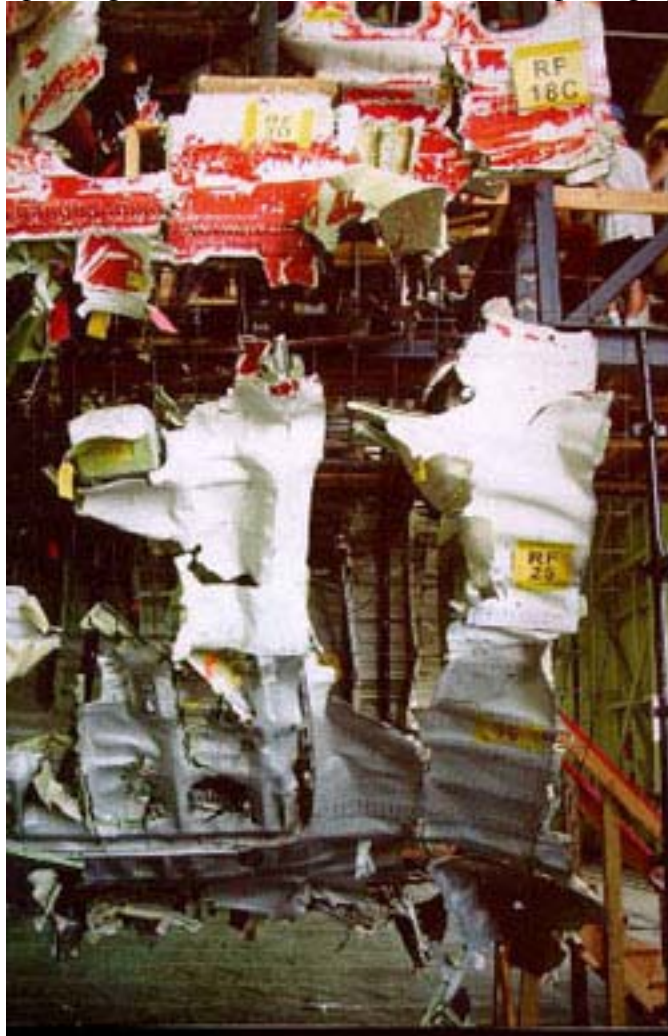
Above is a closeup photograph of about a half of the Trans World Airlines Flight 800 forward cargo door extending from fuselage station 520 on the right to fuselage station 620 to the left in the photograph. The cargo door hinge is in red near the top of the photograph. The outward opening petal shaped oval rupture is located at the forward midspan latch of the forward cargo door.

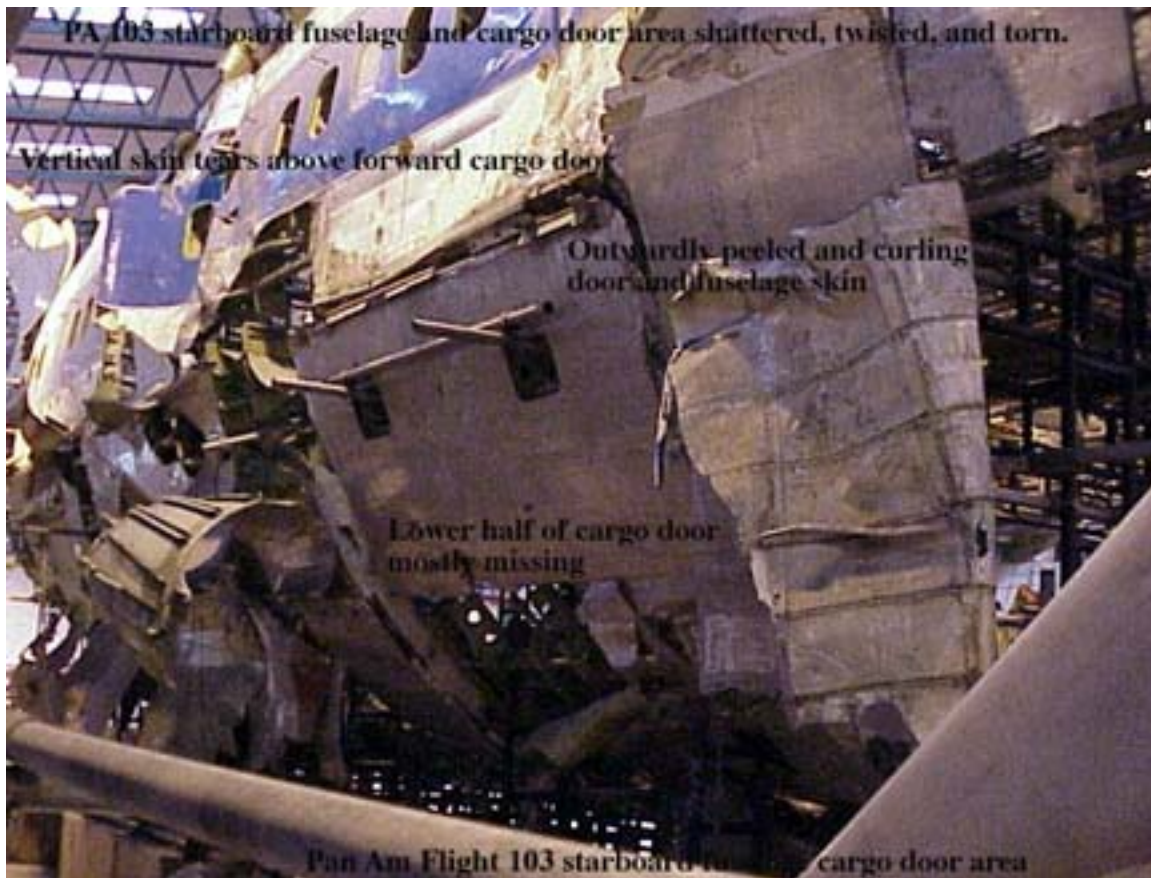
Above AAIB photograph of forward cargo door area of Pan Am Flight 103 shows the peeled back skin, vertical tear lines, and general shattered appearance.

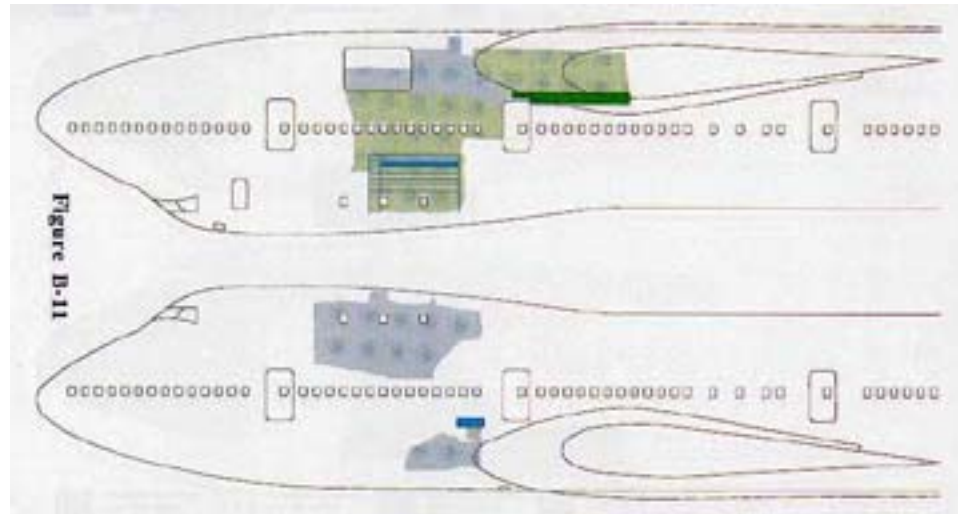
Above drawing from Figure B-11 of the AAIB report shows the large amounts of fuselage skin around the forward cargo door (top drawing) torn away at initial event time while on the port side (bottom drawing) at the same time, only a few pieces are torn off. The dark blue rectangle is the very small 'bomb explosion' shatter zone which is purported to have caused the aircraft to break in two.

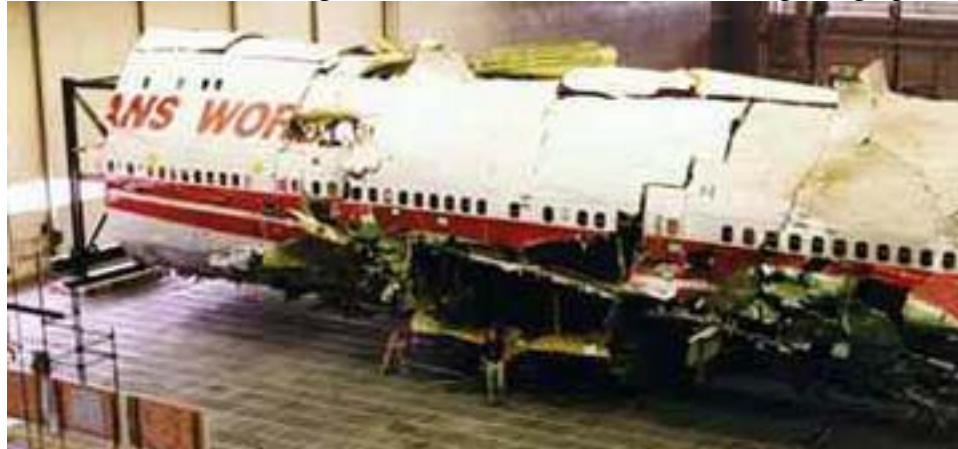
Above photograph shows the smooth port side forward of the wing (nose to left in photograph), while directly opposite the starboard side is shattered and torn. There was no inflight damage to engines Nos. 1 or 2, both on the port side of the aircraft.

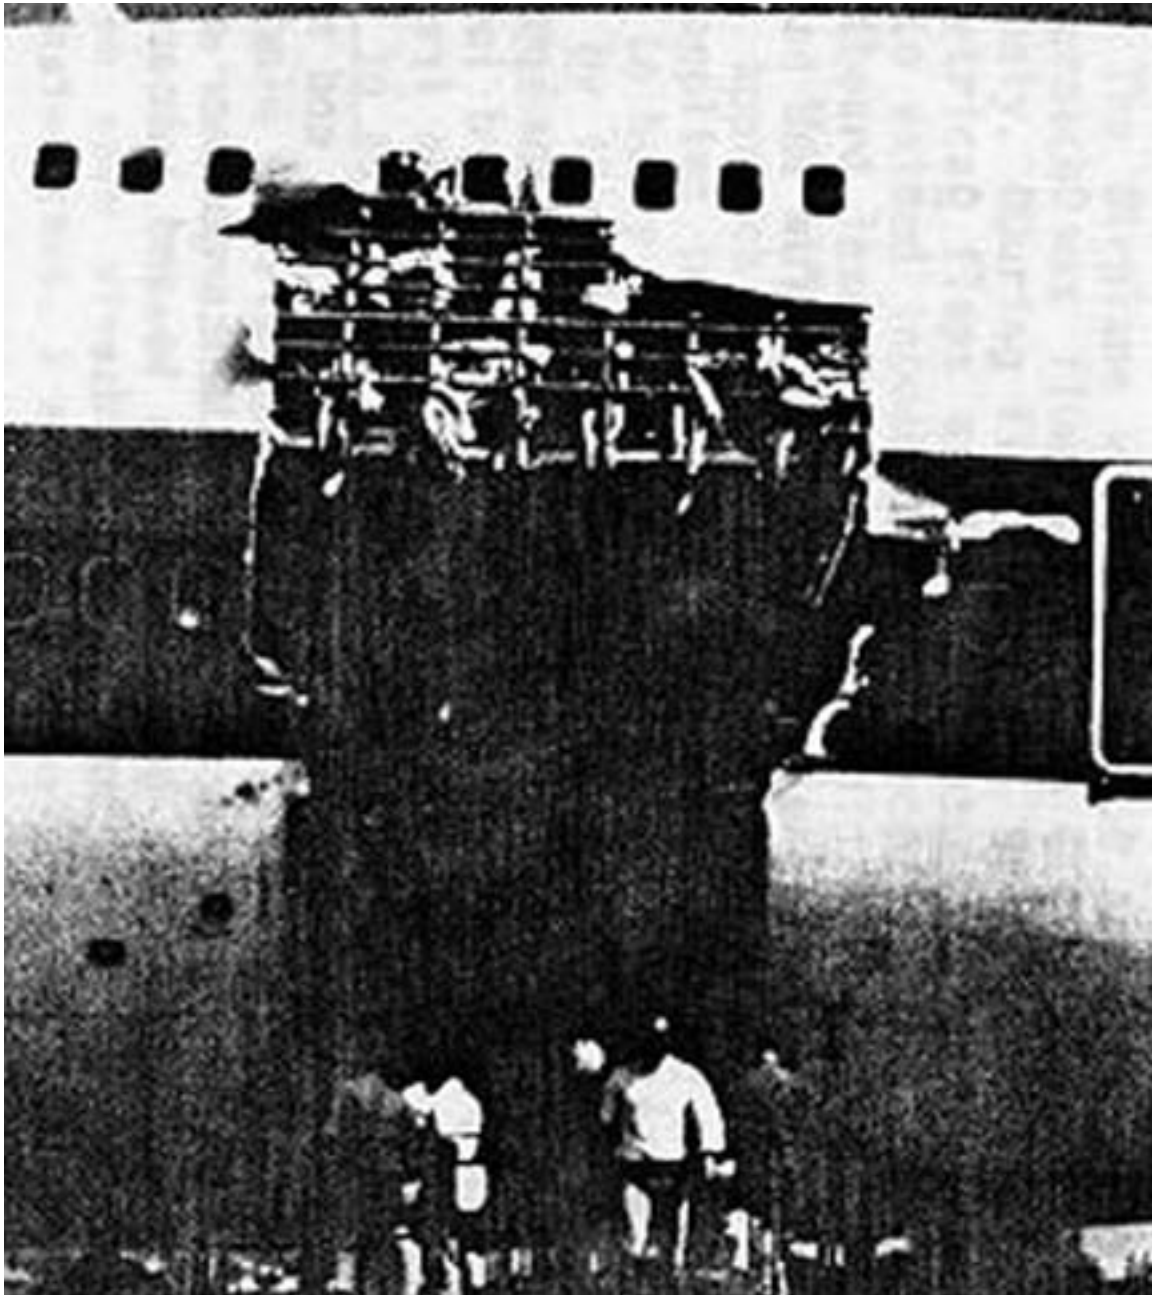
Photo from NTSB AAR 92/02 of hole in United Airlines Flight 811 made by inadvertent opening of forward cargo door in flight.

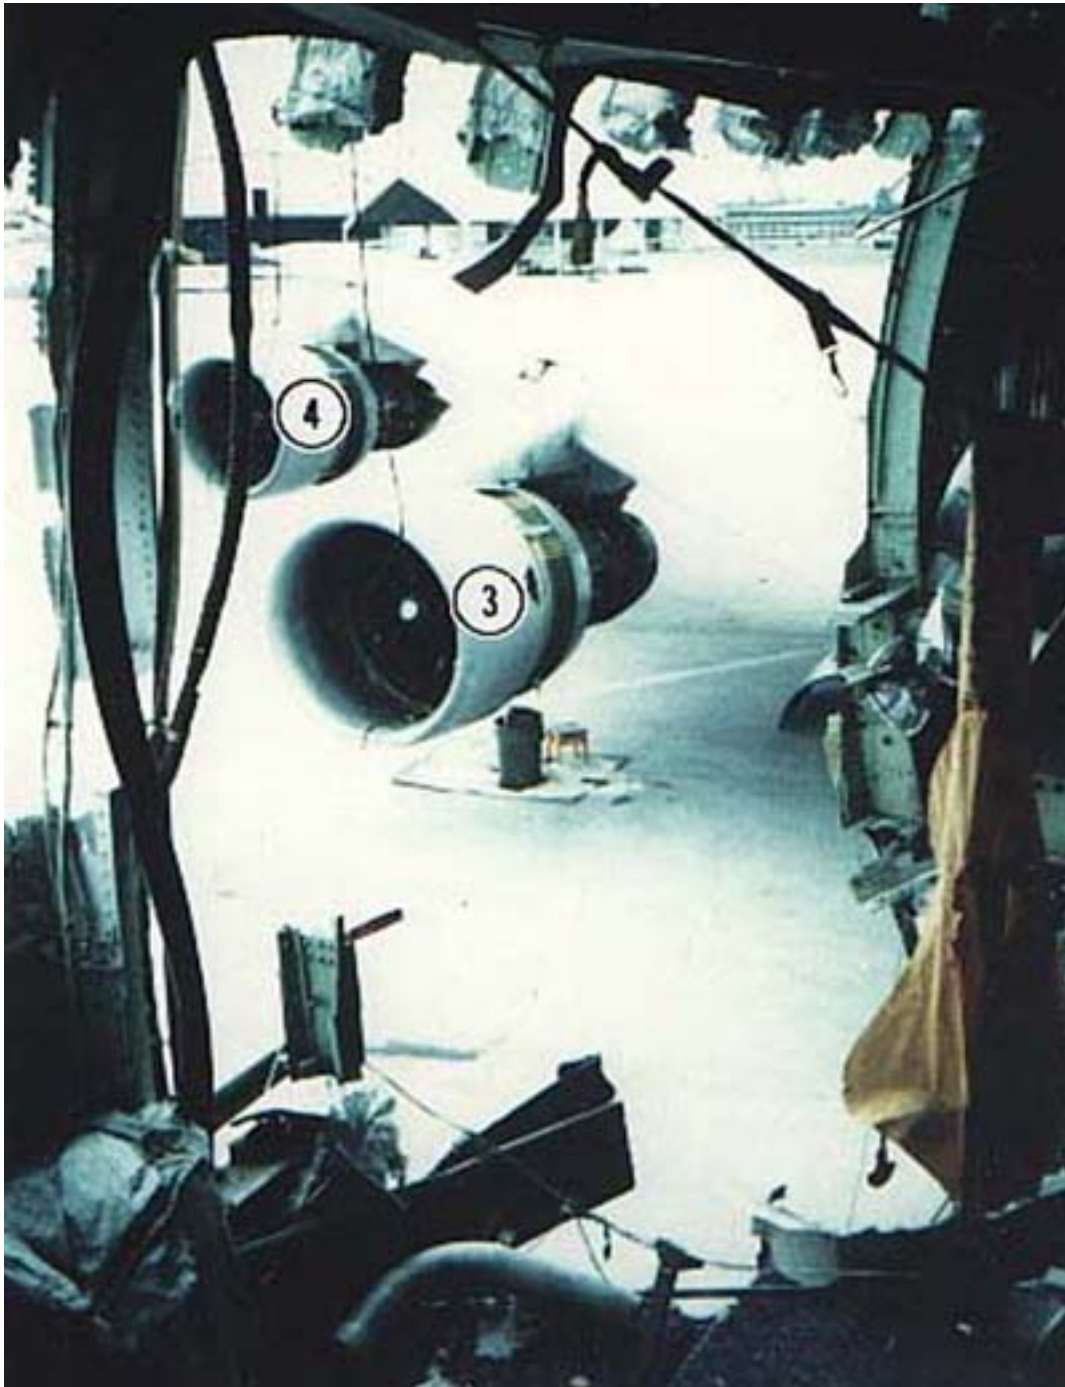
Photo from inside United Airlines Flight 811 showing the hole caused by inadvertent opening of forward cargo door in flight revealing engine numbers three and four which received the ejected foreign objects which caused the fire and internal engine damage.

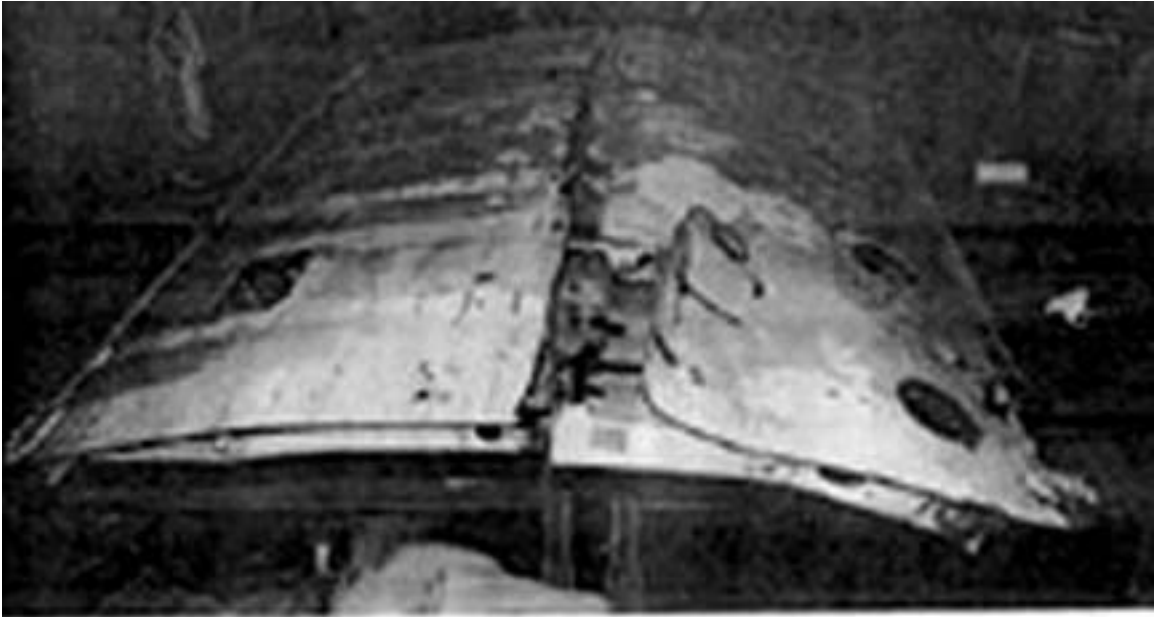
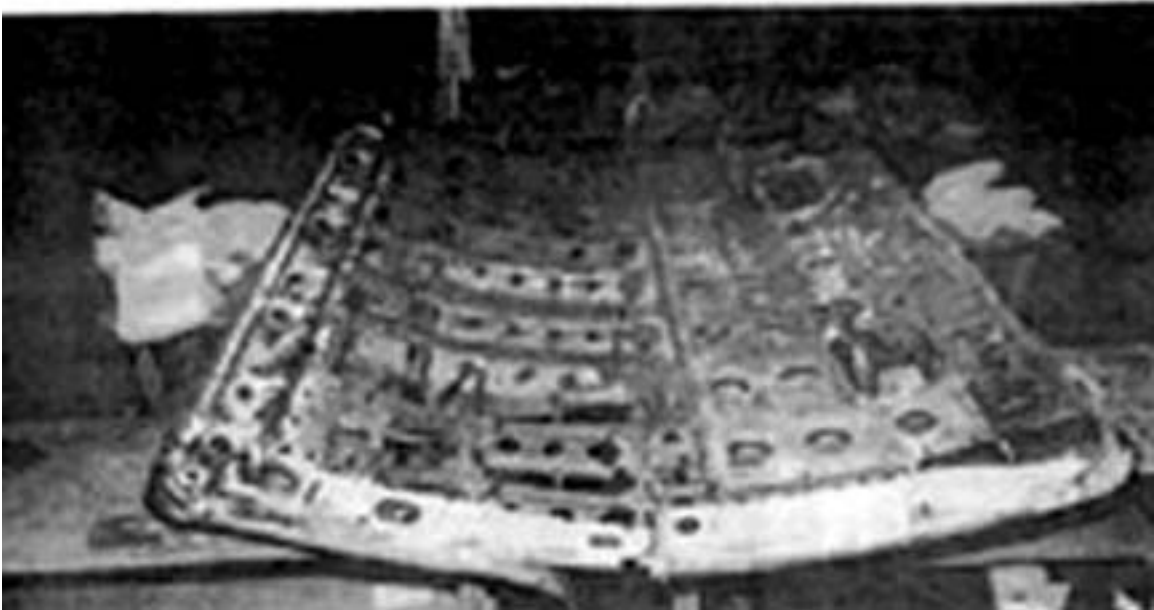
Photo from NTSB AAR 92/02 for United Airlines Flight 811 showing both halves of the retrieved door, the longitudinal split at midspan latches, and the peeled away skin from the aft midspan latch.

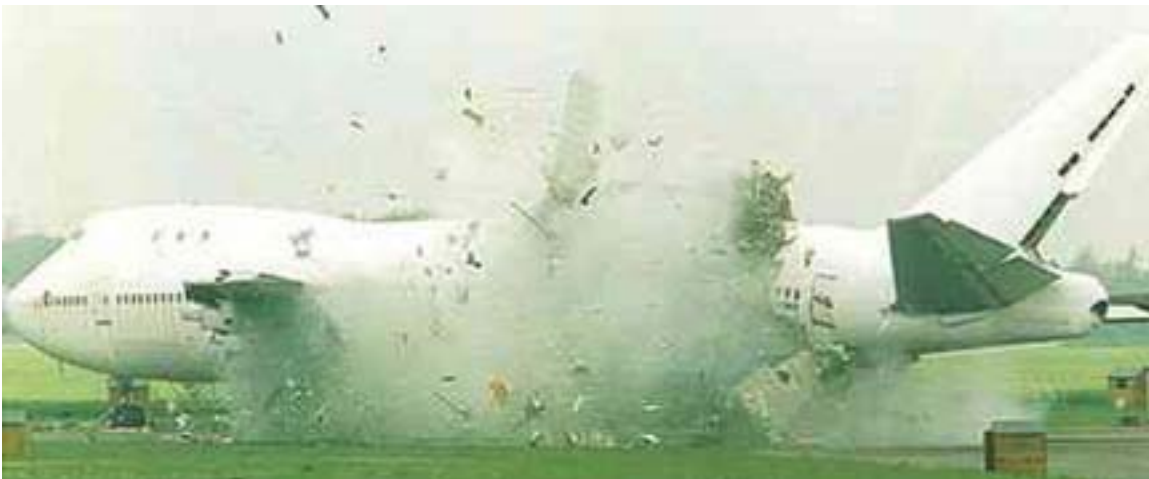
Staged bombing of a Boeing 747 at Bruntingthorpe UK showing the massive damage which occurs when a real bomb goes on in a Boeing 747.

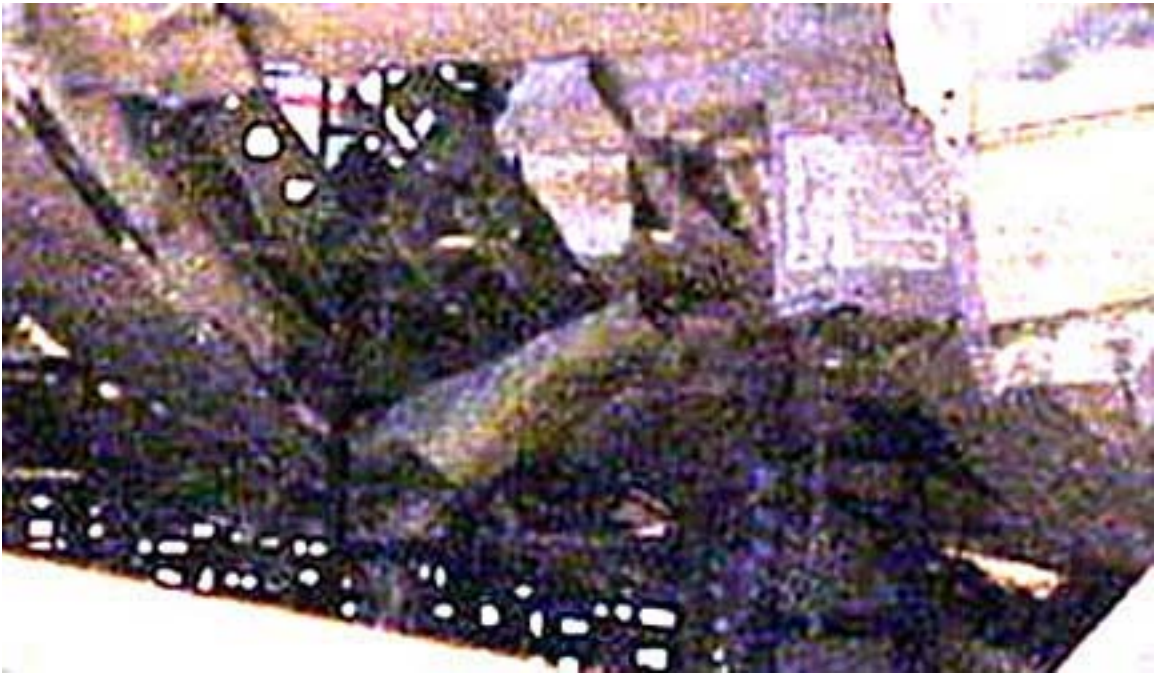
Closeup of the peeled back skin from the aft midspan latch of the forward cargo door of Pan Am Flight 103.

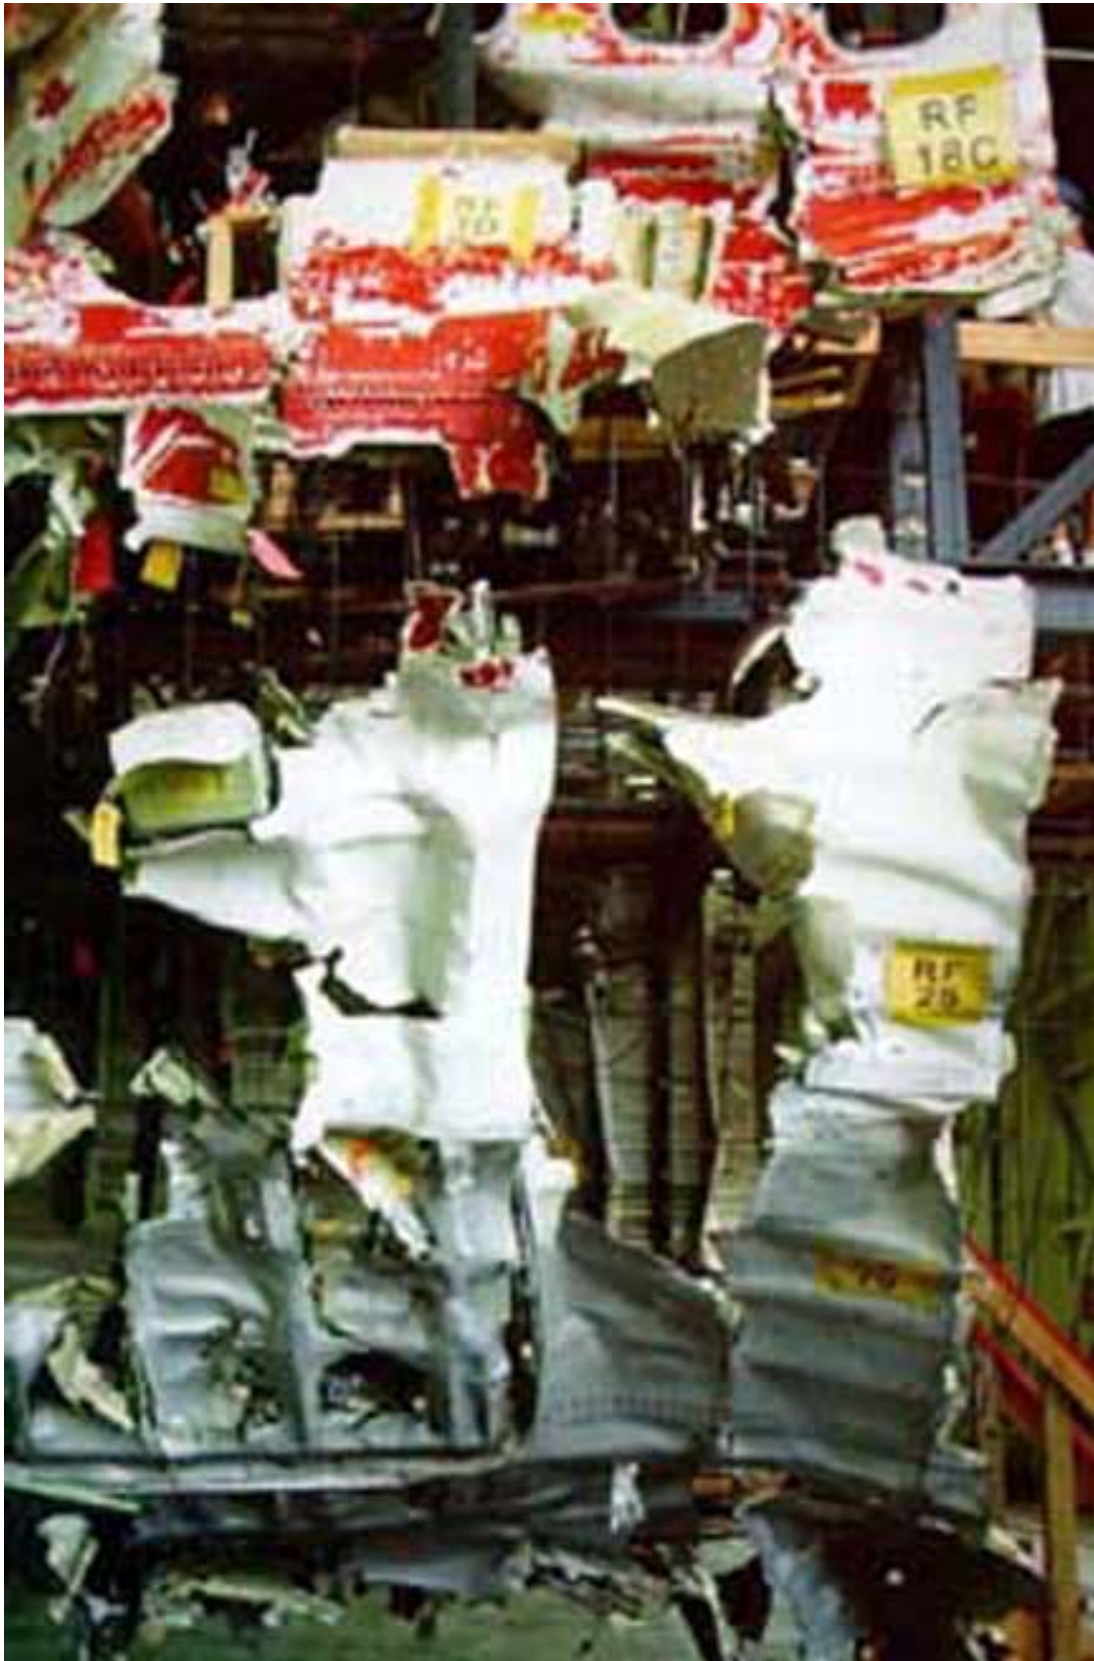
Photograph above showing outwardly and petaled shaped skin around forward midspan latch.

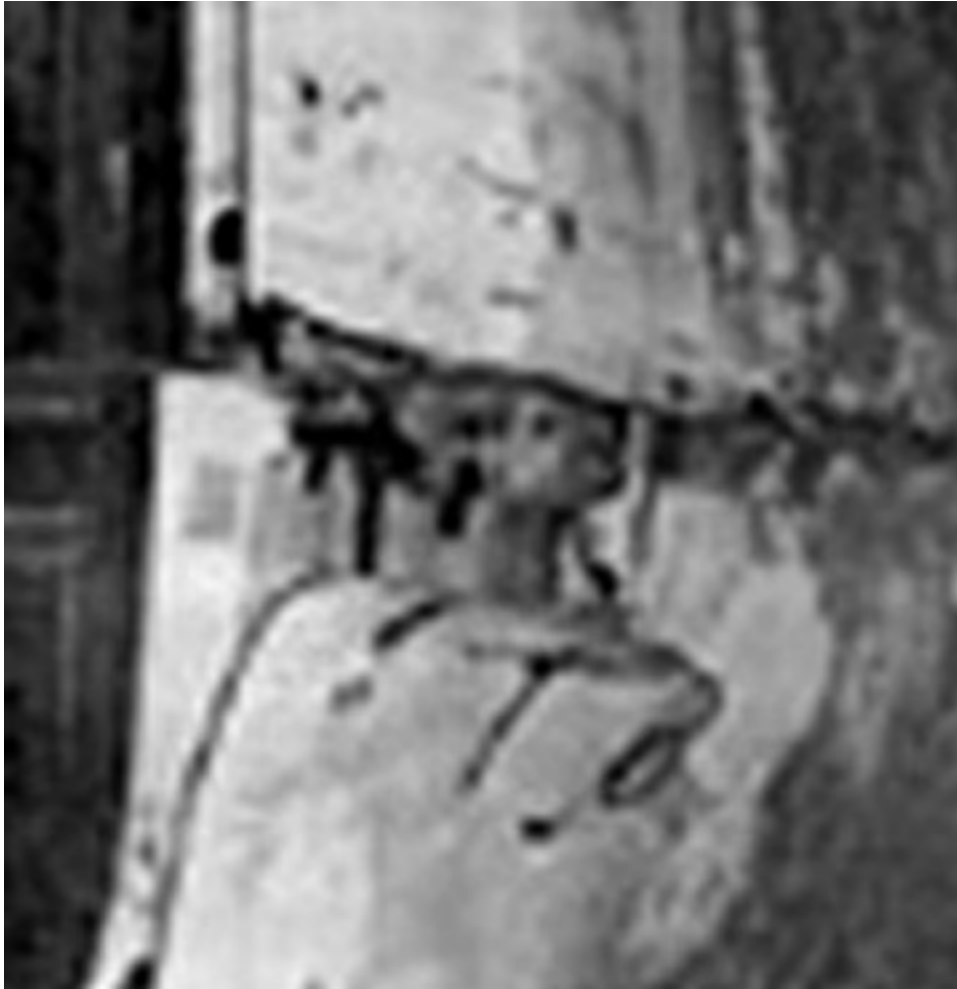
Photos from NTSB AAR 92/02 for United Airlines Flight 811 showing bottom half of the retrieved door, the longitudinal split at midspan latches, and the peeled away and down skin from the aft midspan latch.

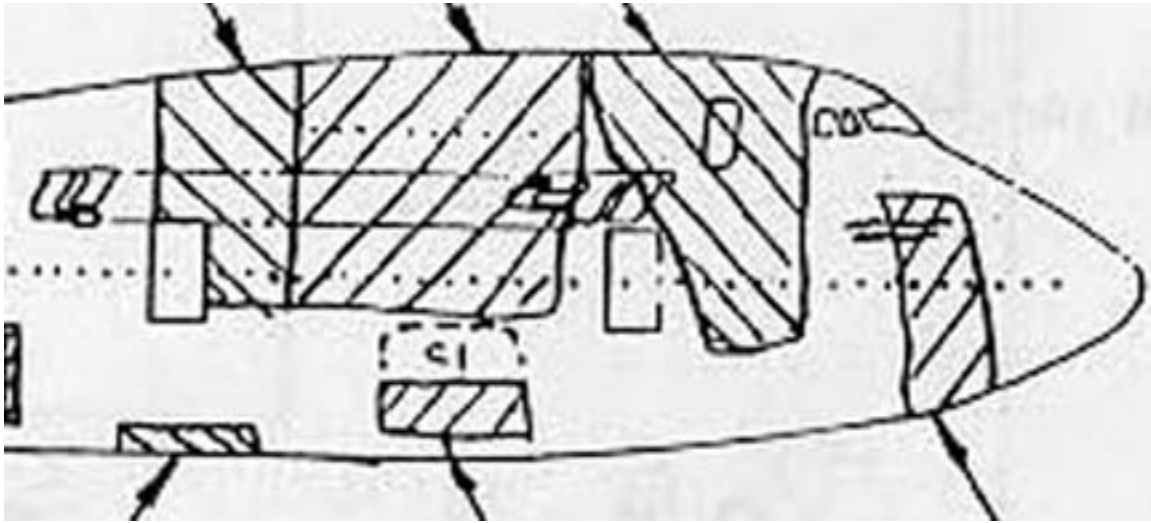
Reconstruction drawing above from the Kirpal Report and the CASB report on Air India Flight 182 showing the longitudinal split of the forward cargo door and the vertical tearing of the skin above the door.

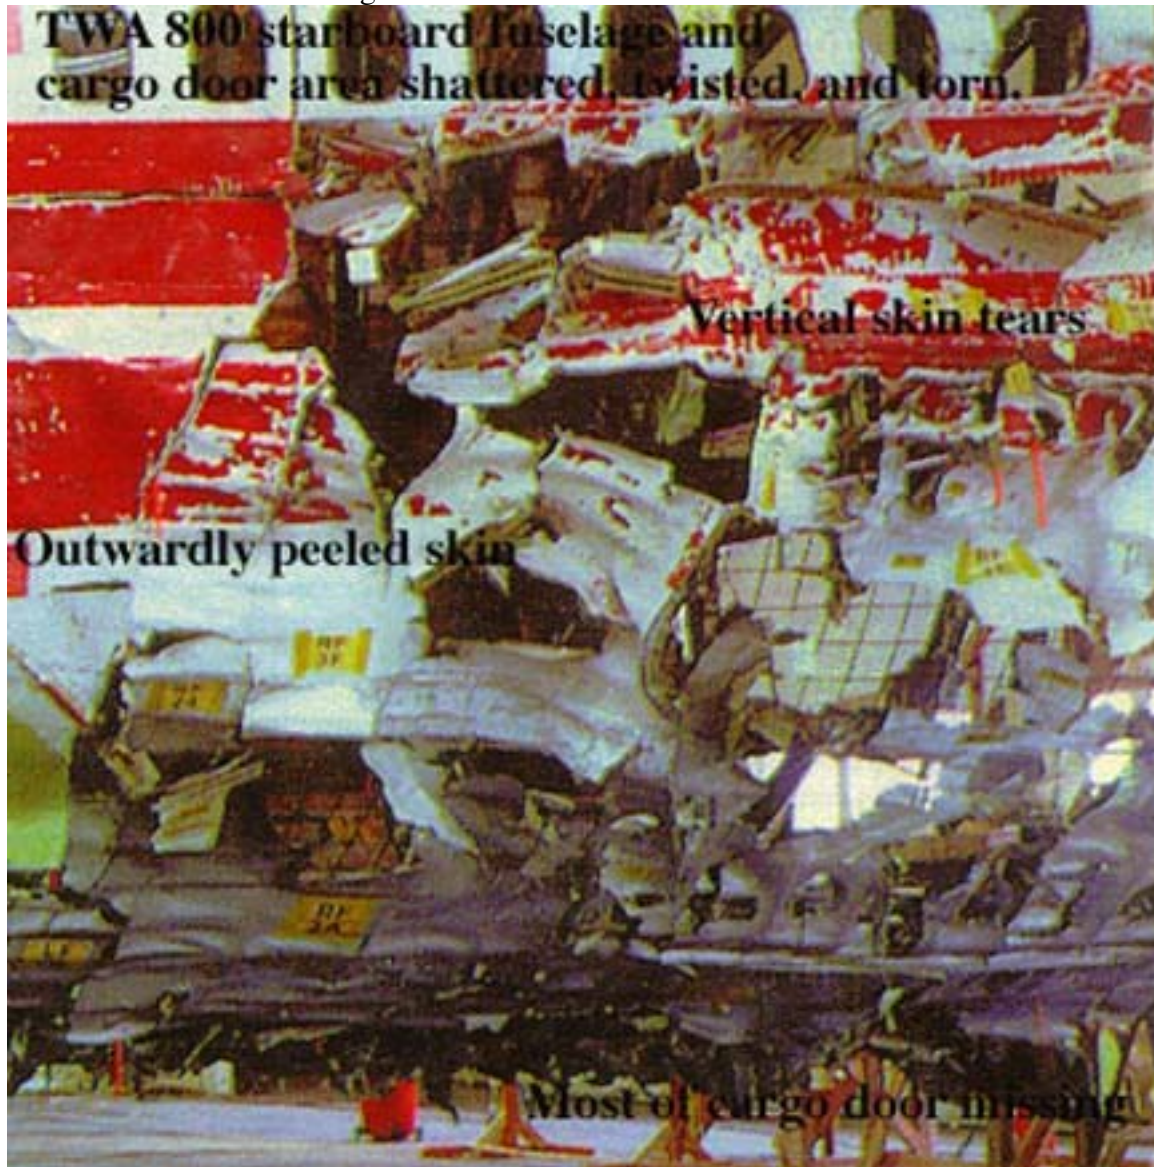
Shattered starboard side around forward cargo door of Trans World Airlines Flight 800 revealing outwardly and petaled shaped skin around aft midspan latch.

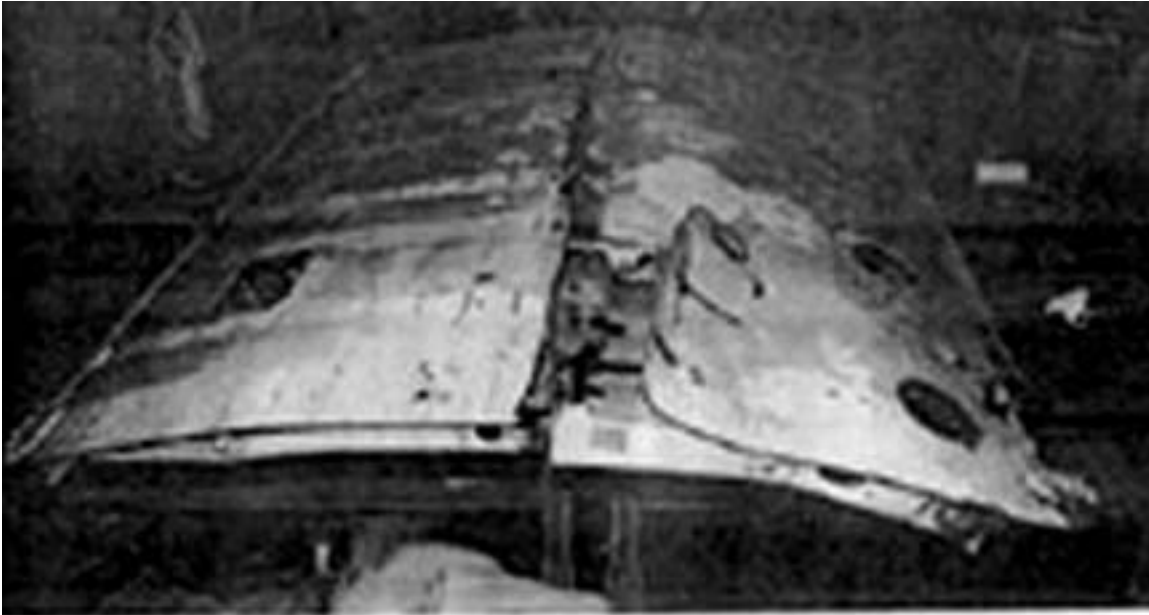
United Airlines Flight 811 forward cargo door showing missing aft pressure relief door and jammed open status of forward pressure relief door according to NTSB AAR 92/02.

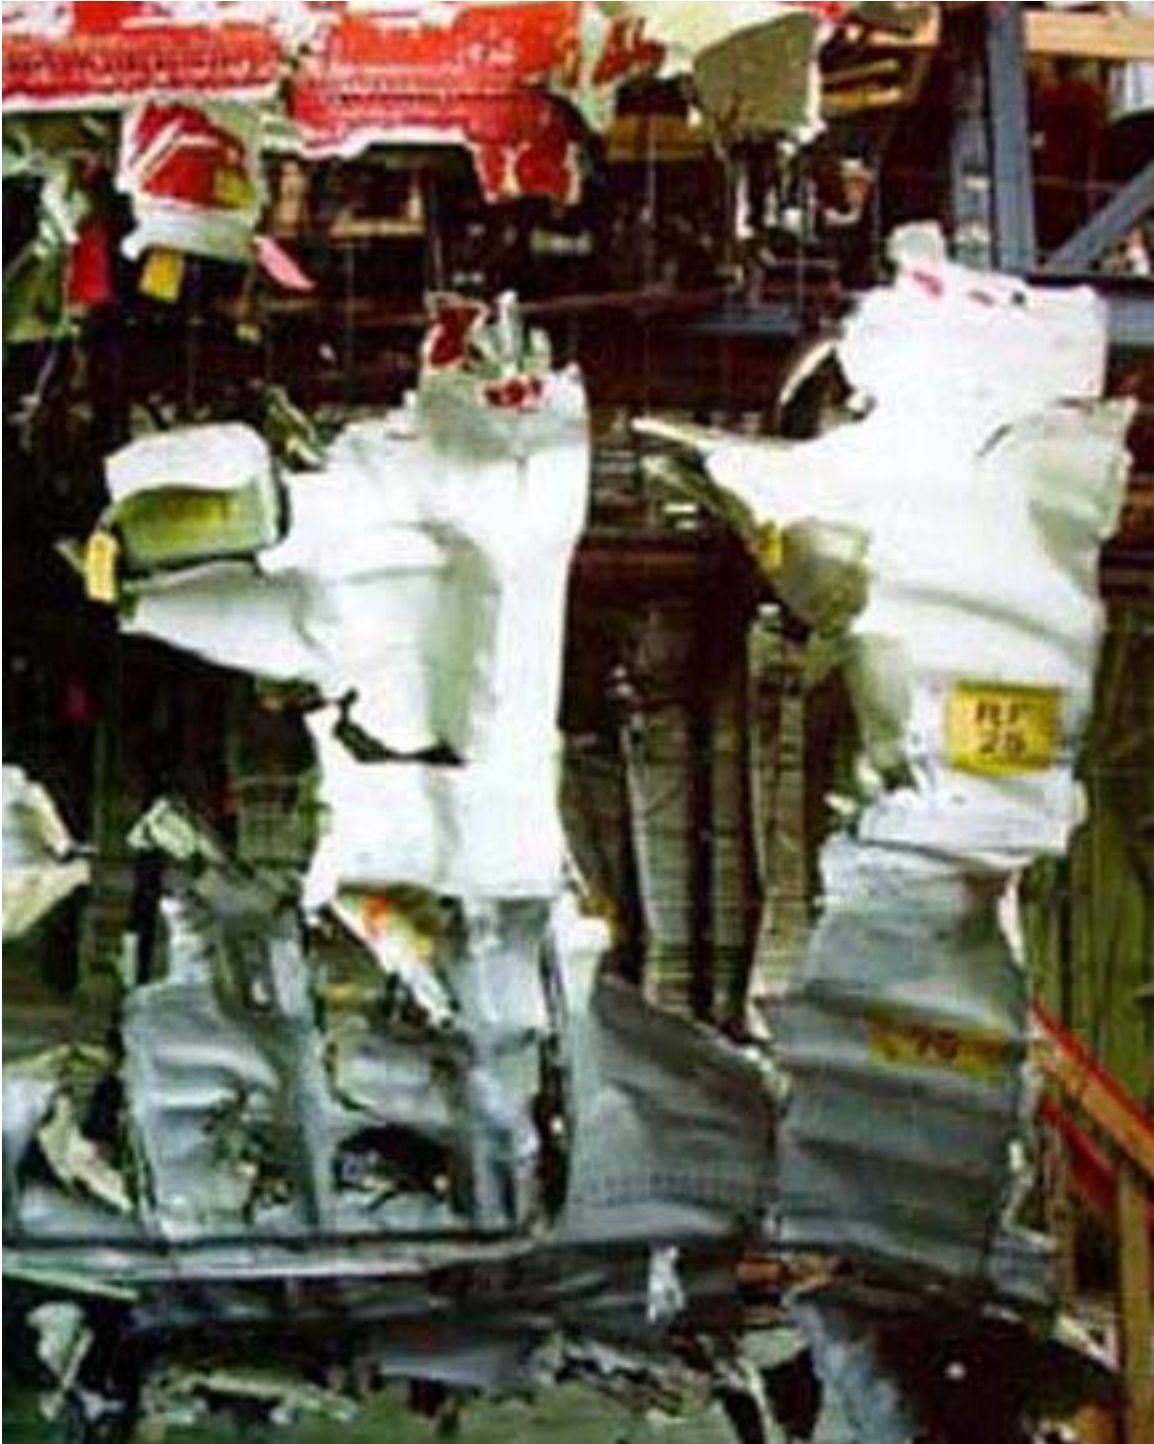
Trans World Airlines Flight 800 Forward cargo door showing separated and replaced forward pressure relief door.

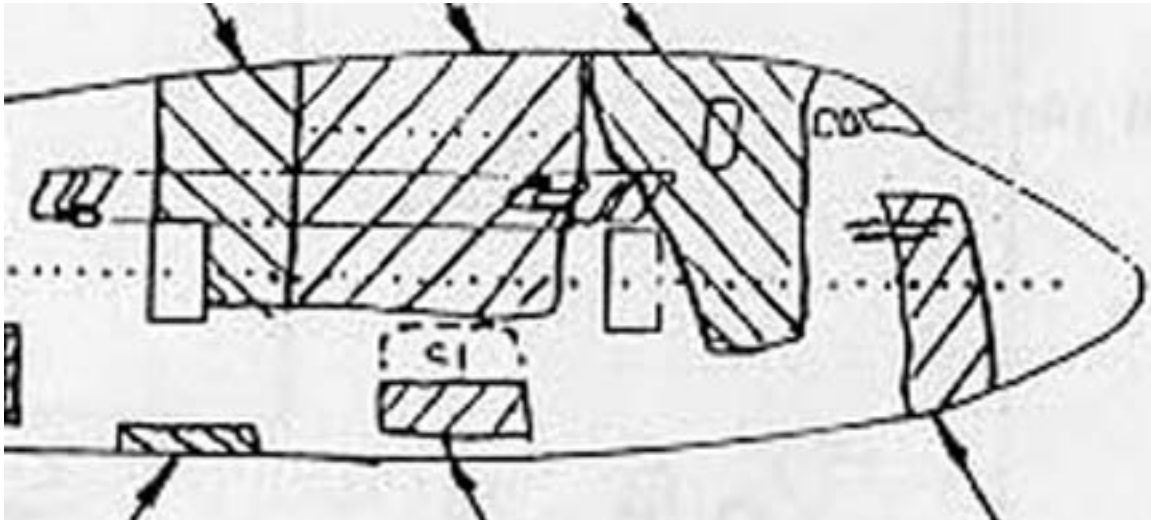
Air India Flight 182 Forward cargo door showing missing top half of door including the aft and forward pressure relief doors.

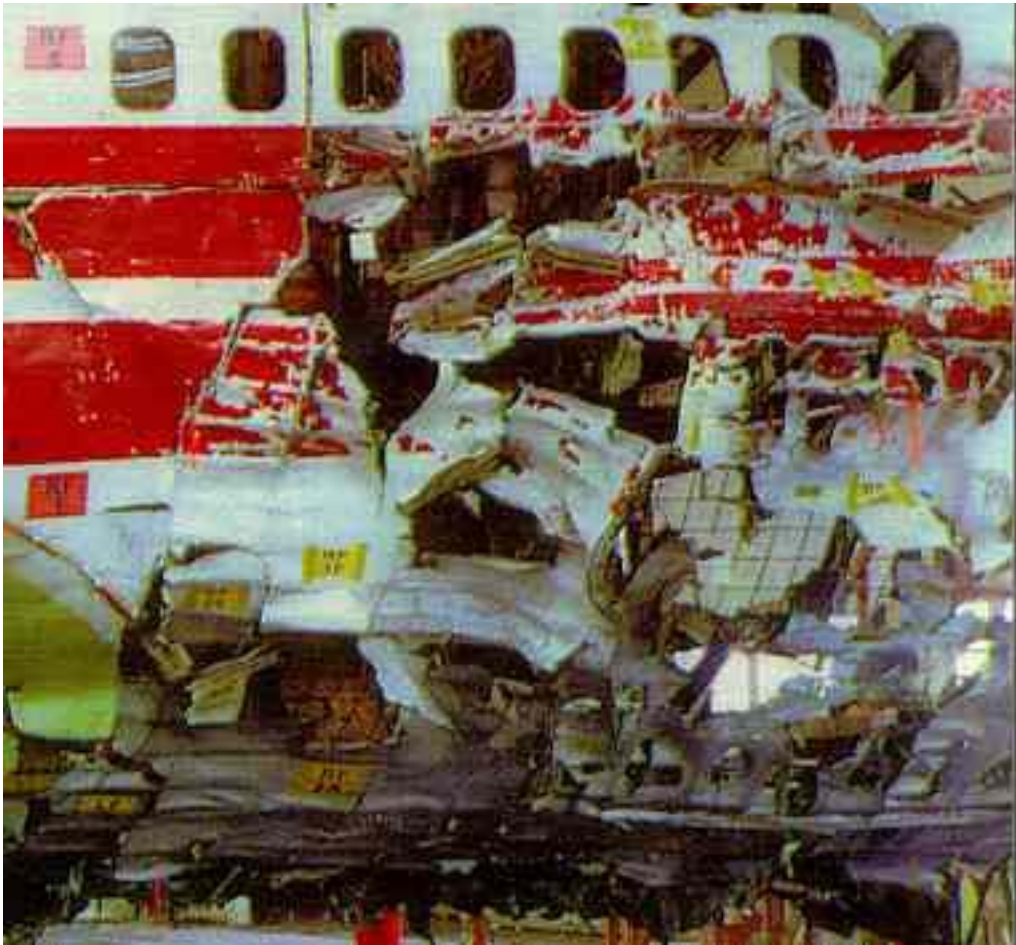
Right side of aircraft, nose to right, forward cargo door area revealing red paint smears found only in this area of Trans World Airlines Flight 800.

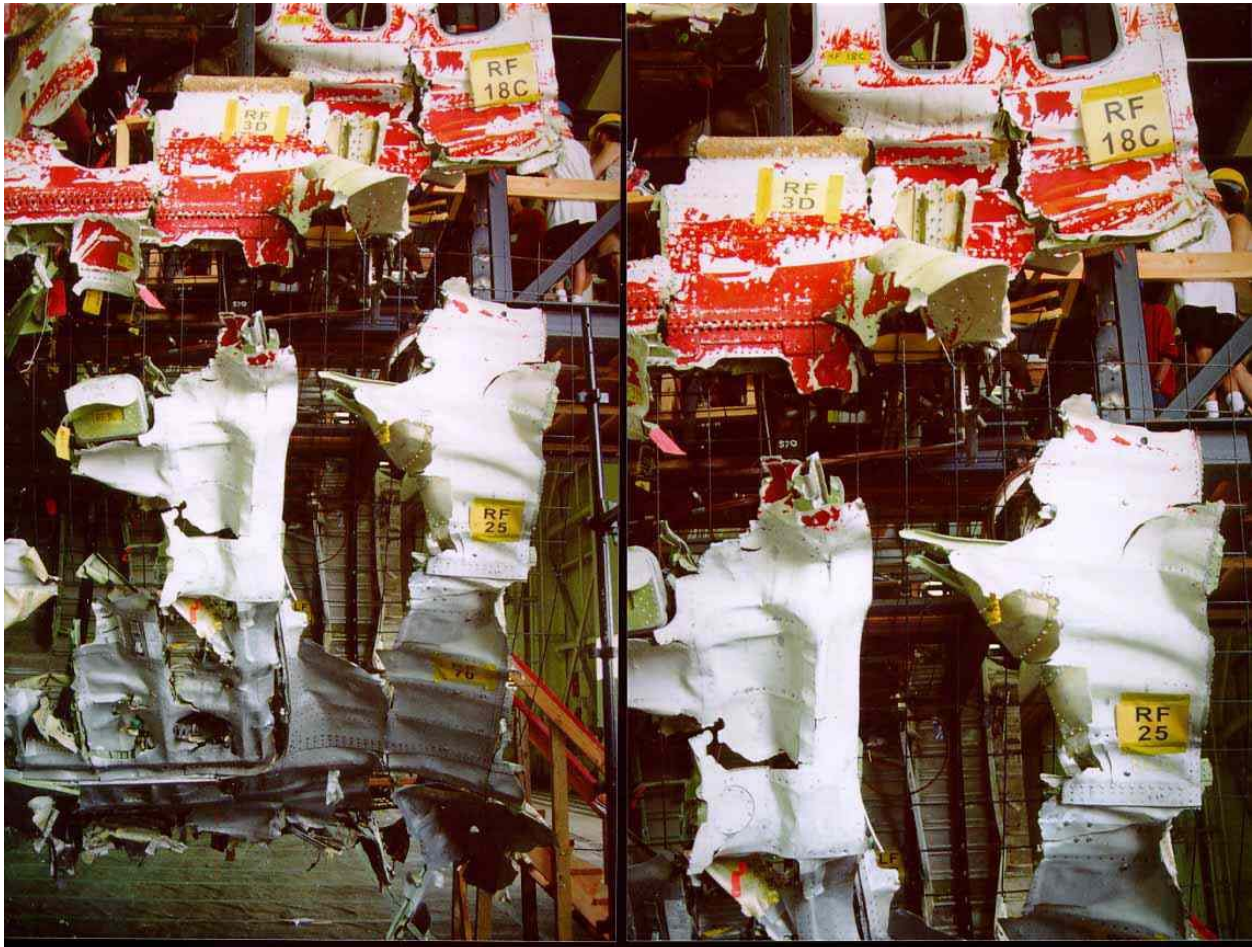
Two pictures of forward cargo door forward midspan latch area right side of aircraft, nose to right revealing outward peeled in petal shape and strange red paint smears.

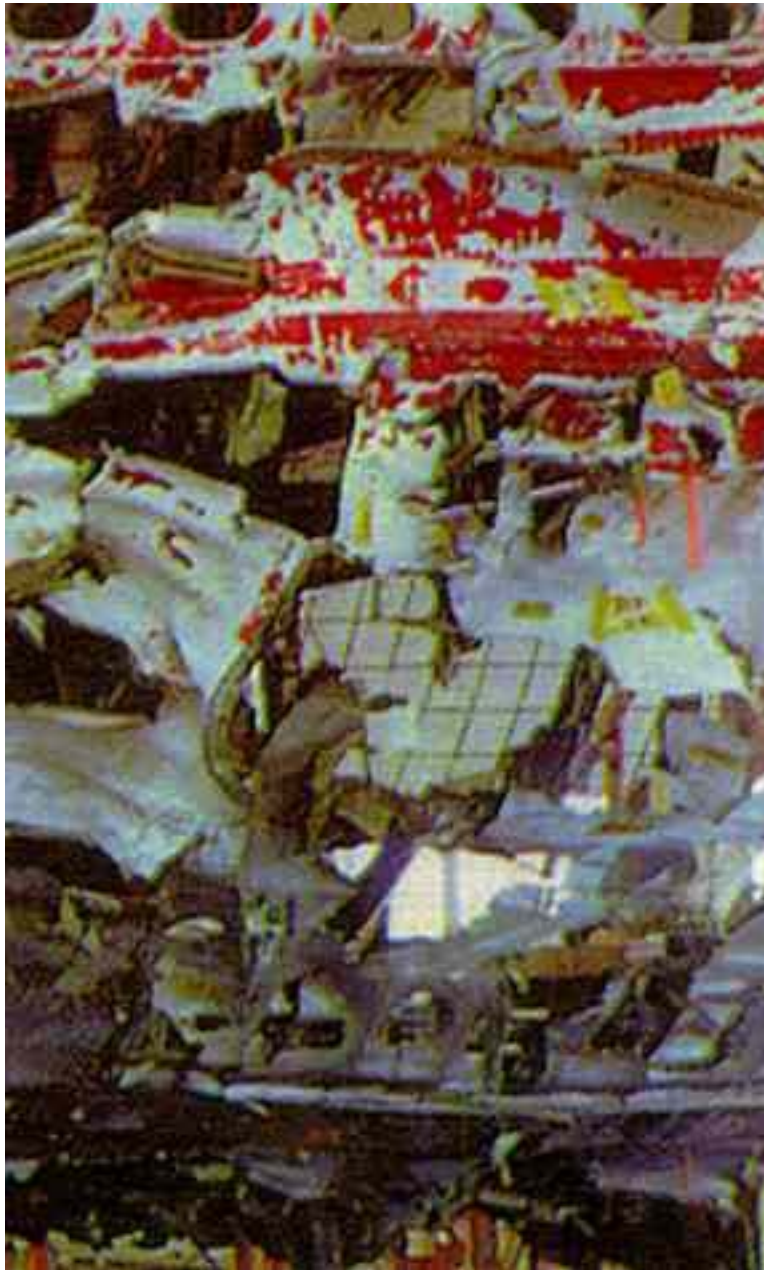
Right side of plane, aft midspan latch of forward cargo door area revealing outward, petal shaped rupture at aft midspan latch and red paint smears.

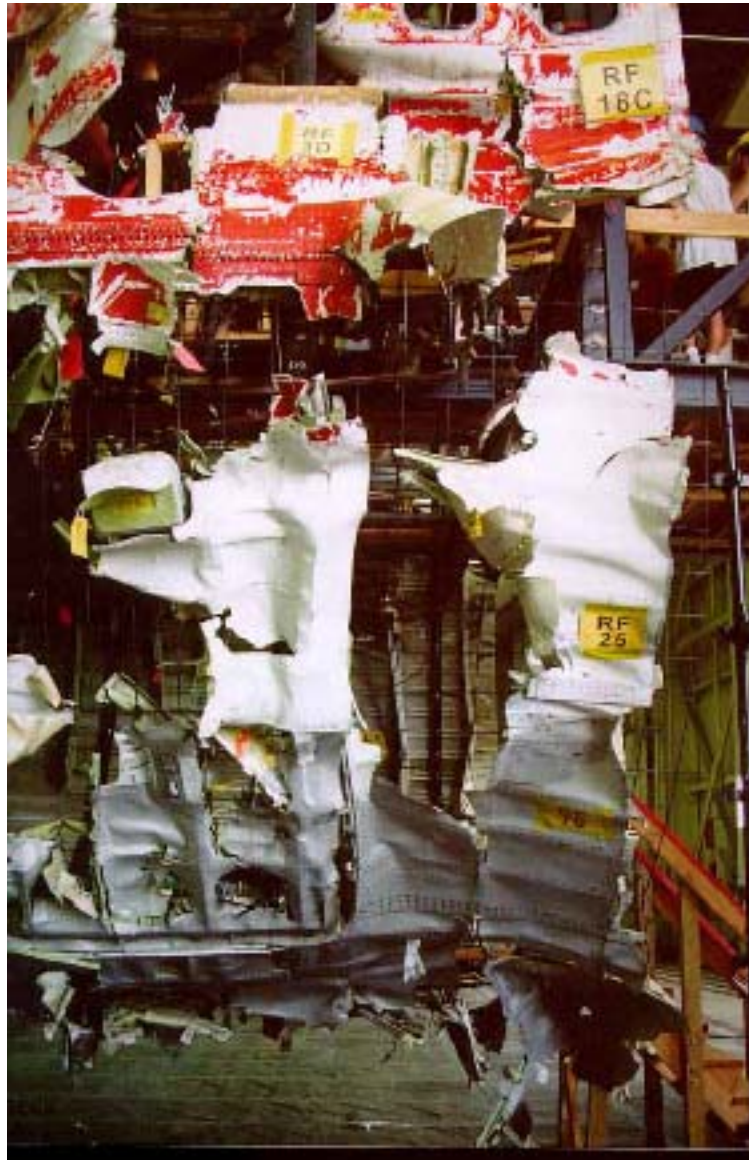
The large gaping hole to the left of the yellow tag marks the spot of the outward peeled rupture of the missing forward midspan latch of the forward cargo door of TWA 800. Also note red paint smears above hinge, inward pillowing of skin lower down on door pieces, and absence of most of recovered door pieces.
